# Prackovice Tunnel – Prague’s Portal Modelling and Construction

M. Hilar, M. Srb, J. Nosek

**SUMMARY:** The Prackovice tunnel is located on the section of the D8 highway between towns Lovosice and Řehlovice. The tunnel has two unidirectional tubes of length 270 m and 260 m, each tube has two lanes. The tunnel was excavated in basalts and tuffs, the rock mass was significantly affected by chamber blasting which were realised in the basalt production in the quarry Prackovice in past. In 2005 a pilot adit was excavated as part of realised site investigation. The tunnel excavation was realised without significant complications in 2008 and 2009. The following paper describes some aspects of construction and modelling of Prague’s portal of the tunnel, where due to higher deformations additional stabilisation measures had to be adopted.

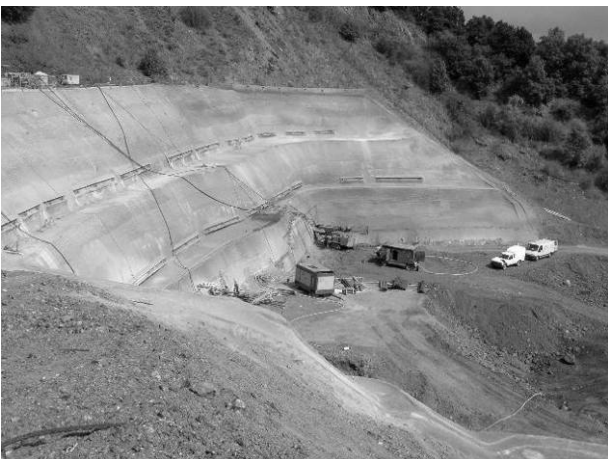
The tunnel excavation started by excavation of the Prague's portal and by stabilisation of slopes in the portal area in 2008 (Fig.1). The portal is supported by rock dowels together with a sprayed concrete on the surface. Overall stability of the area is ensured by three levels of cable anchors. The whole first level was grouted. Micropile umbrellas with length 20m were realised from portal above profiles of particular tubes. The grout consumption for one drill reached up to 5000 l (multiple of normal values).

Figure 1. Prague's portal area prior start of excavation

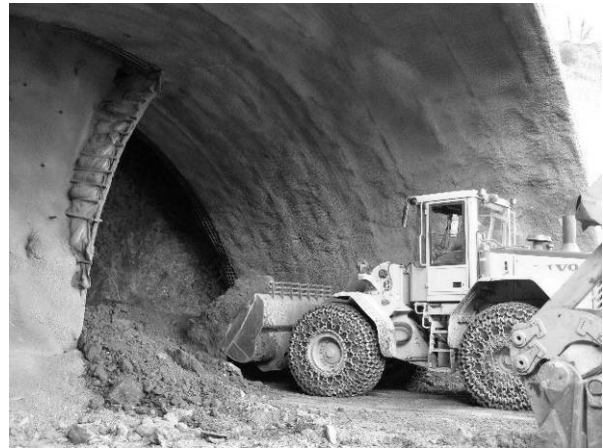
2008. NATM class 5a was used for excavation in the portal area, a top heading was splitted into two parts a spiling was used to protect tunnel crown (Fig.2).

Figure 2. Excavation with splitted top heading

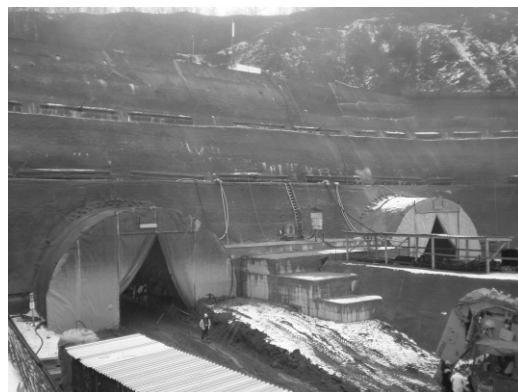
In the beginning of 2008 a higher trend in deformations of the right side of the portal was recorded which was caused by interruption of prestressed cable anchors intervening into the tunnel profile of the RTT. Utilisation of the portal wall surcharge together with installation of 5 cable anchor of length 28m were adopted as additional support measures. A block from insitu cast concrete (Fig.3) of the volume 350 m<sup>3</sup> was anchored using 32 inclined micropiles of the length 12m. The last anchor disallowing further excavation was interrupted after stabilization of deformations.

Figure 3. View of surcharging concrete block between tunnels
