Collapse of Březno railway tunnel made by prevault (perforex) method in the Czech Republic

ABSTRACT

A single track railway tunnel was constructed by prevault (Perforex) method in tertiary sedimentary ground conditions as a by-pass of an open coal mine. After excavation of about half of the 1,7 km long tunnel, sudden, daylight collapse happened and destroyed about 100 m of the tunnel with prevault shotcrete lining, leaving the excavation machine buried as the crew left to safety.

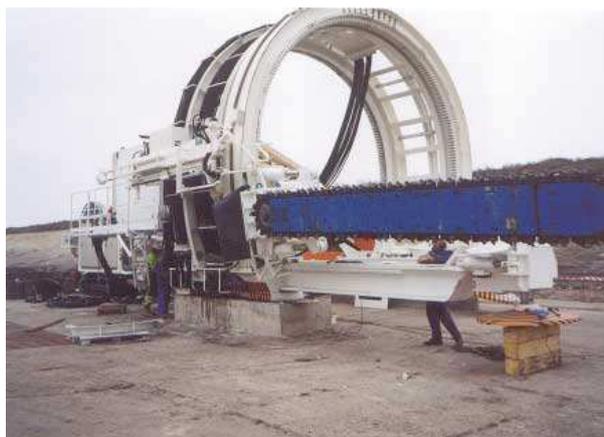
Figure 4. Prevault/Perforex method and machine

Specifically for the Brezno tunnel design was imperative to use the prevault/Perforex method

(Fig. 4) of excavation and primary support installation. Verification of this method did not consider the actual construction method used. One reason may be that it was the first (and so far the last) use of this method in the Czech Republic and, therefore, no experience on the Client's, the Designer's and the Contractor's side. Method and technology for excavation and primary support was probably considered as a "ready made" mechanized tunneling and designer's attention was focused on definitive final lining made of reinforced concrete with closed invert. Disproportion between geometry, dimensions and requirements on primary lining and final lining is obvious (Fig. 3). And practical impossibility to close the tunnel's cross section with invert vault in adequate time after excavation of the advance step is crucial.

Technical reasons of the collapse were connected with the used technology (prevault/Perforex) and lack of design verification of the primary support in existing geotechnical conditions. Construction reasons were of smaller importance. Method itself can be effectively used only in very specific range of “optimum” conditions with soft (for chain cutting) but stable geology. Other than optimum geology leads to either slow progress (if quick closure of the profile is required) or stability problems in weaker grounds and to slow progress (due to cutting) in strong grounds. Reference projects show problems on many of them.

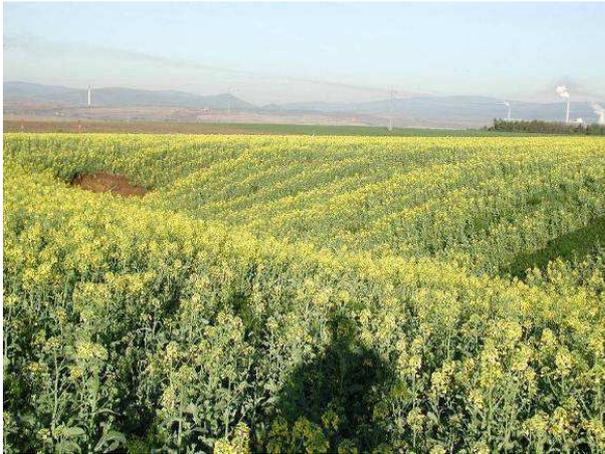
Figure 8. Collapsed tunnel profile and surface depression

Excavation of 1477m railroad tunnel started in March 2002 and was scheduled for completion in March 2003. Approximately 77 m of the tunnel, between station km 2.029 – 2.106 at a depth of 27 m, collapsed on 05th May 2003, when construction progress was already significantly delayed. Prior to the tunnel failure, only approximately 860 m of the tunnel excavation had been completed. Excavation rate of advance indicated problems with the schedule and progress.

On May 5, 2003, at 4:30 a.m. the tunnel experienced large and accelerating deformations leading to breaking of the prevault lining starting with bottom slab upheave at prevault no. 188, progressing in domino-like effect over the prevaults no. 177 to 195, leading to total tunnel failure in this section and progressing to the surface (Fig. 8).

Project was finally completed by excavation through collapsed part strengthened by piling, micropiling and grouting in original excavation direction, and a consequent counter drive from the exit portal. Both drives were performed based on principles of the NATM.
