# ZMÁHÁNÍ HAVAROVANÉHO ÚSEKU TUNELU BŘEZNO

## RECOVERY OF A COLLAPSED SECTION OF THE BŘEZNO TUNNEL

MATOUŠ HILAR, VLADISLAV JOHN

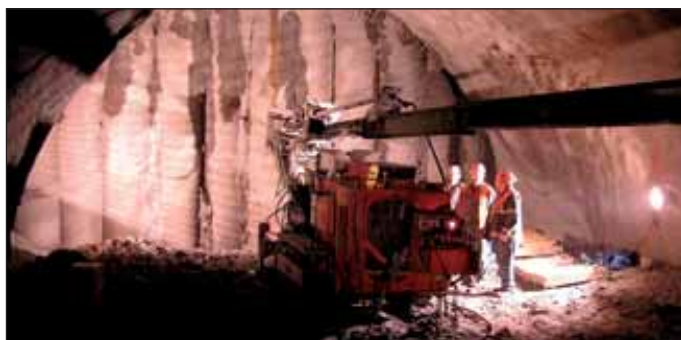
Obr. 6 Realizace jádrových vrtů do profilu tunelu z prostoru před pilotovou přepážkou (foto M. Hilar)

Fig. 6 Drilling of core holes to the tunnel profile from the space in front of the dividing pile wall (photo M. Hilar)

The crown of the tunnel was regularly protected by means of canopy tube pre-support. The drilling for the pre-support was carried out from the front side of each pile wall. The tubes were always tailed into the next pile wall (they bridged the entire distance between neighbouring dividing walls). Efforts were made in the beginning to embed the canopy tubes into jet grouted columns to be carried out above the excavated cross section. However, the execution of jet grouting in the tunnel overburden stopped after the completion of the excavation of the initial three compartments, similarly to the jet grouting within the tunnel profile.

Přístup tunelu bylo pravidelně chráněno pomocí mikropilotových deštníků, které byly vrtány před každou pilotovou stěnou. Mikropiloty byly vždy vetknuty do následné pilotové stěny (tj. překlenovaly celou vzdálenost mezi sousedními přepážkami). Ze začátku byla snaha realizovat jednotlivé mikropiloty do sloupů tryskové injektáže nad profilem, ale podobně jako v oblasti profilu tunelu bylo i v nadloží tunelu od tryskové injektáže po ražbě prvních tří sekcí upuštěno.

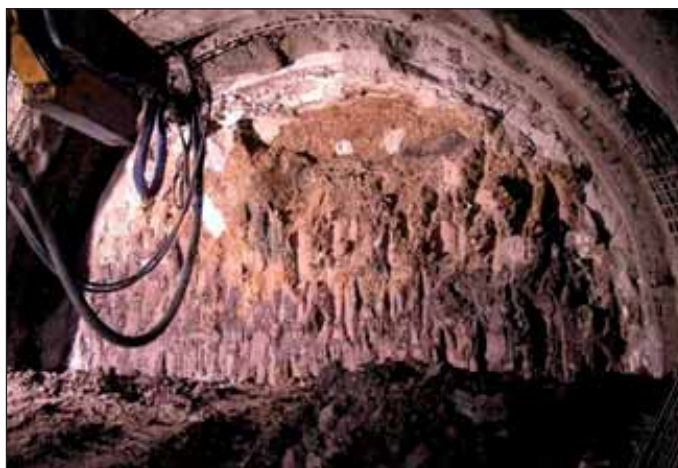
The effect of the jet grouting rather fell short of expectations. The jet grouted columns which had been expected to reinforce the ground, were perceivable only in the non-cohesive Quaternary material; unfortunately, they were not much visible in the cohesive clay or claystone (see Fig. 7). The attempt to drill through the jet grouted columns for installation of the pre-support tubes was similarly little successful. We can state that the jet grouting carried out within the tunnel profile acted rather as pressure grouting. The cement grout filled various fissures and empty spaces in the collapse rubble. The highest accumulation of the grout was found at the beginning of the excavation, under the preserved prevault created by the Perforex machine (see Fig. 8). Because of the relatively favourable consistency of the mostly cohesive material – the collapse rubble, and with respect to the fact that stabilisation of cohesive soils by jet grouting is a difficult task, it was decided after the excavation of the third section to abandon the idea of the stabilisation by jet grouting.

Účinek tryskové injektáže očekávání příliš nesplnil. Očekávané sloupce zpevňující čelbu byly patrné pouze v nesoudržném materiálu kvartéru, v soudržném materiálu jílu či jílovců bohužel sloupce příliš patrné nebyly (obr. 7). Obdobně se pokus o vrtání mikropilot (deštníku mezi přepážkami) do sloupů tryskové injektáže také příliš nezdařil. Lze konstatovat, že v profilu tunelu působila trysková injektáž spíše jako injektáž tlaková. Cementová suspenze vyplnila různé trhlinky a volná místa v závalovém materiálu. Největší koncentrace suspenze byla patrná na začátku ražby pod zachovanou předklenbou vytvořenou strojem Perforex (obr. 8). Vzhledem k poměrně příznivé konzistenci převážně soudržného materiálu závalu a vzhledem k obtížnosti sanace soudržných zemin tryskovou injektáží bylo po ražbě třetí sekce rozhodnuto od sanace pomocí tryskové injektáže ustoupit.

*Obr. 7 Účinek tryskové injektáže v první sekci zmáhání závalu (foto P. Svoboda)*

*Fig. 7 The effect of the jet grouting in the first compartment of the collapsed tunnel being recovered (photo P. Svoboda)*
